**State of California
The Resources Agency
DEPARTMENT OF WATER RESOURCES
Division of Flood Management**

**JUNE
2003
OFFICE REPORT**

**THE INSPECTION OF FLOOD CONTROL STRUCTURES
ON THE SACRAMENTO AND SAN JOAQUIN RIVERS
AND THEIR TRIBUTARIES**

**Prepared By The
Flood Operations Branch
FLOOD PROJECT INSPECTION SECTION**

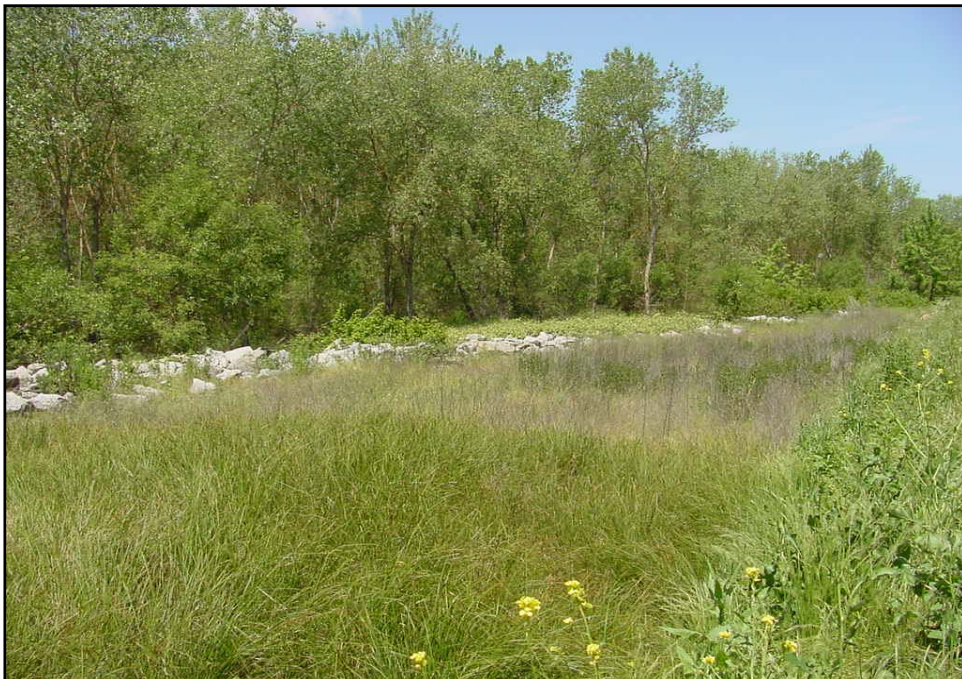
- 1. Condition of quarry rock weir section.**
 - a. Good.**
- 2. Condition of revetments.**
 - a. Good.**
- 3. Accumulation of trash and debris around structure or in the channel.**
 - a. Areas of debris exist along the weir and in the channel.**
- 4. Vegetation around structure or in the channel.**
 - a. Vegetation is very heavy, with trees, brush and berries growing in the weir section and rock revetments.**
- 5. Comments:**
 - a. No clearing done since 1985. The vegetation is extremely dense and could effect the design function of the weir.**
 - b. Poor maintenance.**
 - C. An unauthorized barricade has been installed at each end of Nelson Bend rock weir. The Reclamation Boards' Encroachment Section is investigating.**

Looking northeast from the southwest end of the weir.

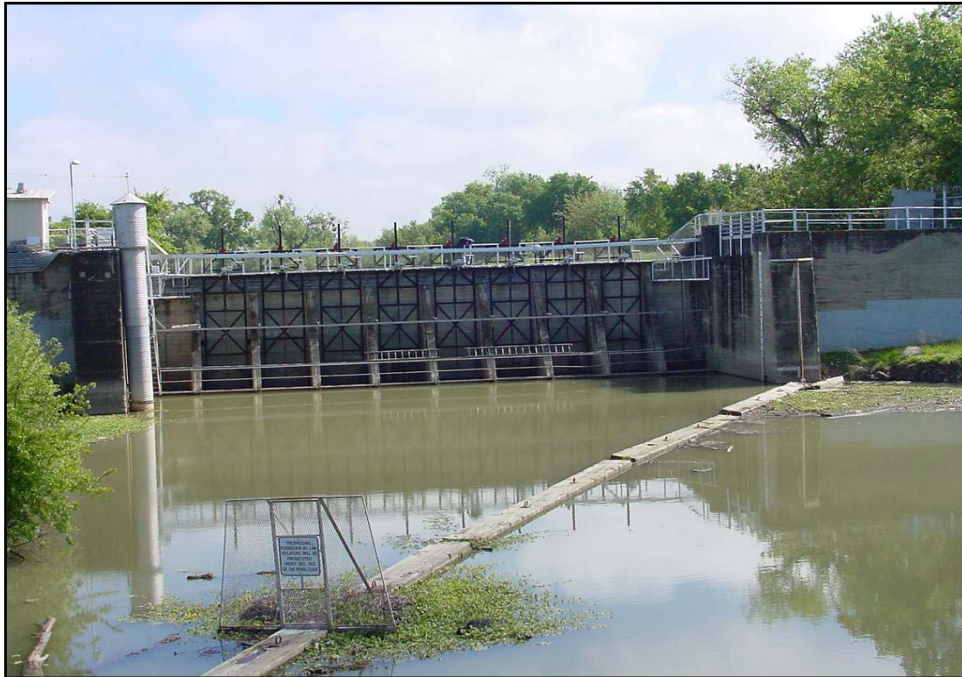
Looking at the upstream side of structure from the left bank.

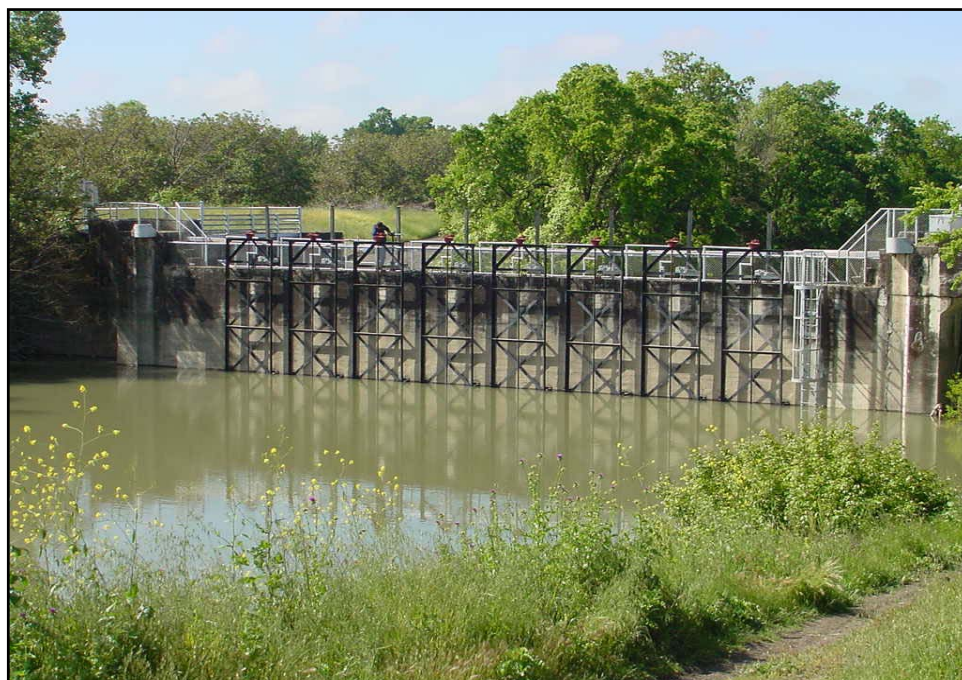
- 1. Condition of outfall structure.**
 - a. Good.**
- 2. Condition of bulkheads.**
 - a. Fair. The large vertical crack and displacement on the downstream side, left bank, has not changed in several years. The crack is not accessible for measurement, but the overall width is estimated to be one inch.**
 - b. The concrete construction joint between the left bulkhead and the outfall structure, upstream side, passes water when the Sacramento River is at high stage. Passage of water was first noticed in 1980.**
- 3. Condition of the pipes.**
 - a. Good.**
- 4. Condition of the control gates, mechanisms, and flap gates.**
 - a. Good.**
- 5. Condition of electrical equipment.**
 - a. Good.**
- 6. Condition of the gauging house and equipment.**
 - a. Good.**
- 7. Condition of the log boom.**
 - a. Good**
- 8. Condition of fill from bulkheads to levee.**
 - a. Good.**

Looking at the downstream side of the structure from the left bank.

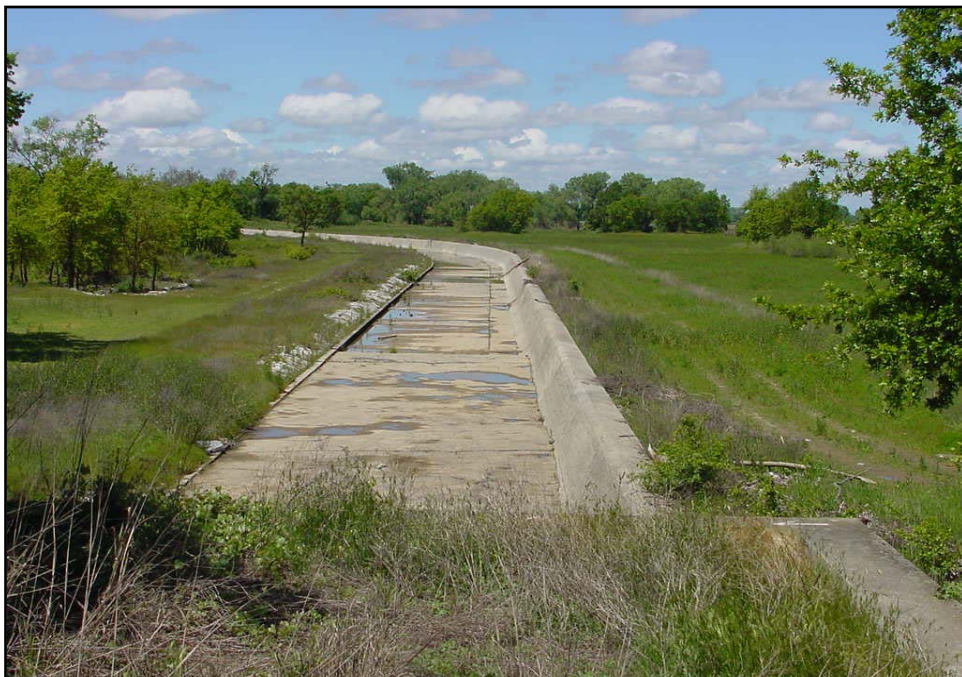
- 1. Condition of concrete weir and stilling basin.**
 - a. Some cracks and spalling exist on the weir and in the stilling basin as previously reported.**
- 2. Condition of concrete abutment.**
 - a. Good.**
 - b. The crack on the downstream side of the right (west) abutment, and the two cracks on the right abutment at Rattlesnake Island, have not enlarged.**
- 3. Condition of revetment.**
 - a. Good.**
- 4. Accumulation of trash and debris around the structure or in the channel.**
 - a. Minimal.**
- 5. Vegetation around the structure or in the channel.**
 - a. Minimal.**
- 6. Condition of gauging house and equipment.**
 - a. Good.**
- 7. Comments:**
 - a. Monitor the cracks and spalling, repair as needed.**
 - c. Remove debris from the stilling basin prior to flood season.**
 - c. Good maintenance.**

Looking north from the southern abutment.

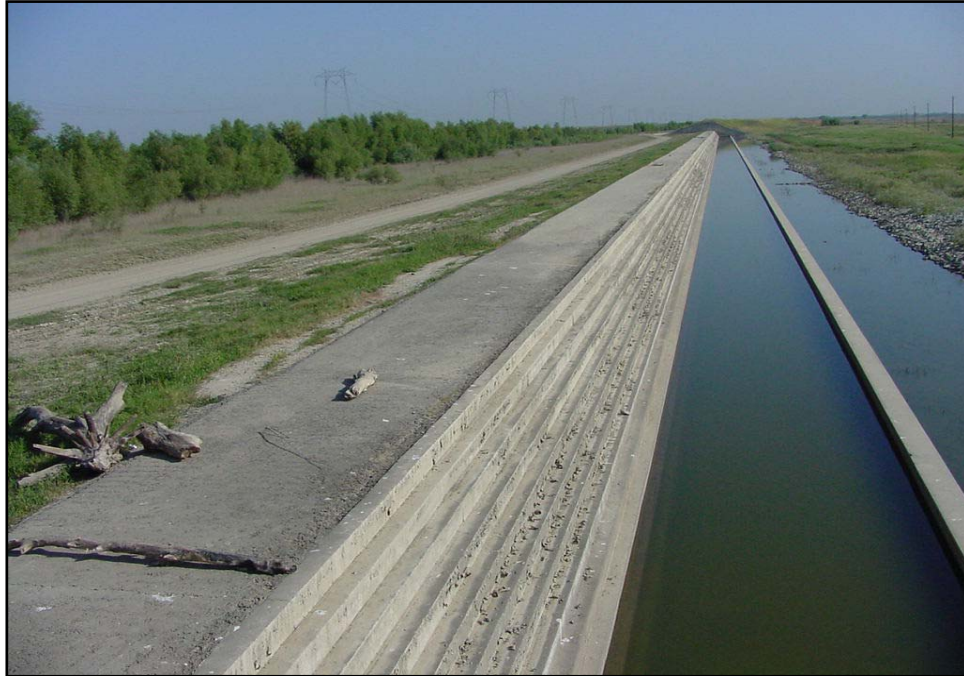
1. Condition of concrete weir structure and stilling basin.
 - a. Good.
2. Condition of drainage structure.
 - a. Good.
3. Condition of concrete abutments and wing walls.
 - a. Good.
4. Condition of revetment.
 - a. Good.
5. Accumulation of trash and debris around the structures or in the channels.
 - a. Moderate debris around the drainage structure.
6. Vegetation around the structures or in the channel.
 - a. None.
7. Comments:
 - a. Remove the accumulated debris around the drainage structure.
 - b. Good maintenance.

**Looking east at the weir and stilling basin.
The weir spills into the Yolo Bypass.**

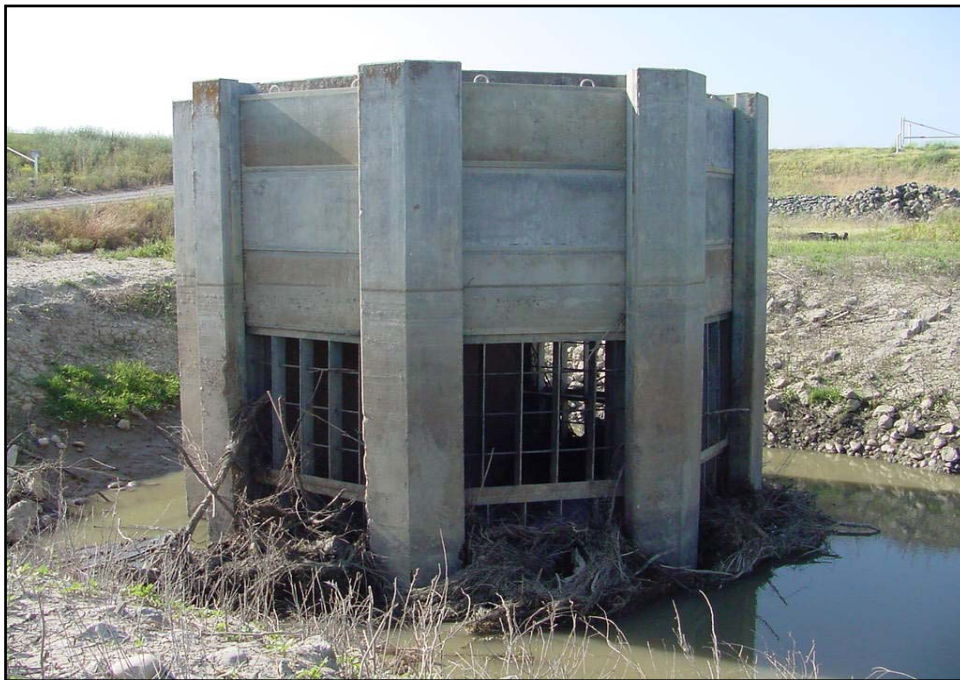
**View of the drainage structure located in the southwest corner of the
Cache Creek Settling Basin. Note the debris around the intake areas.**

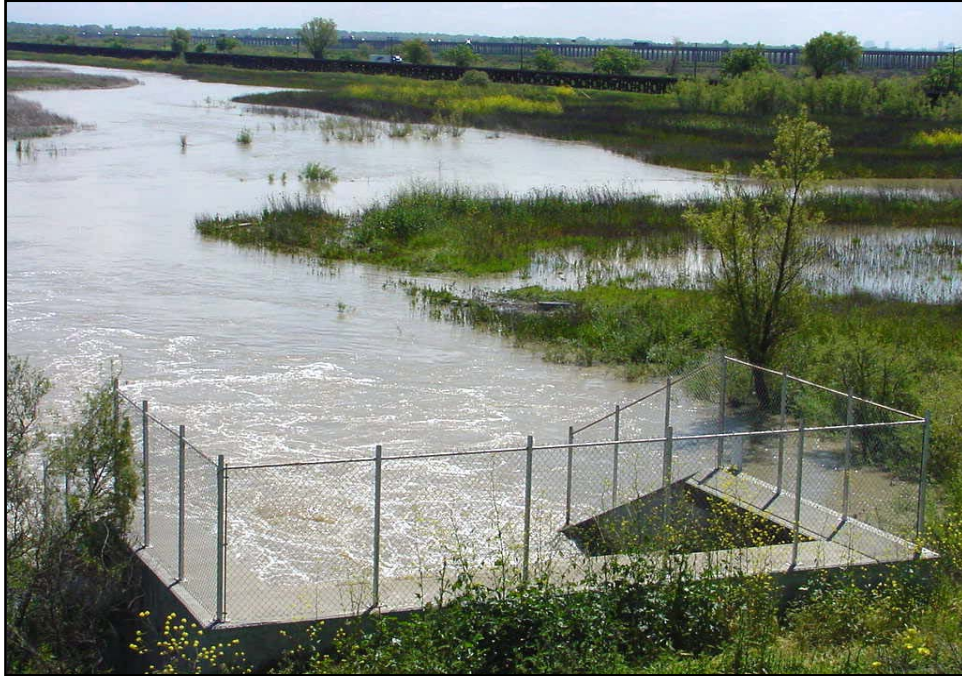
**Looking at the Drainage Structure outlet
releasing water into the Yolo Bypass.**

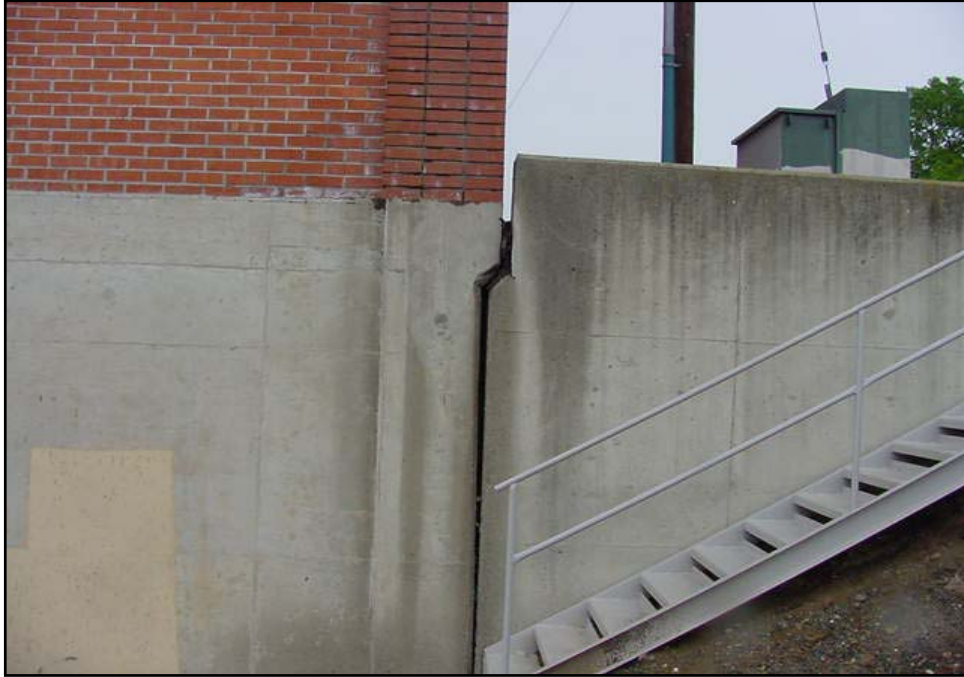
- 1. Condition of the main pump structure.**
 - a. Good.**
- 2. Condition of abutments and wing walls.**
 - a. There is a three and five eighth inch deflection in the retaining wall next to the stairway on the west side of structure.**

- b. There has been no measurable change in the three and five eighth inch deflection in the western retaining wall since last reported in 1998.**
 - c. Outstanding maintenance.**

Three and five eighth inch deflection in the west retaining wall.

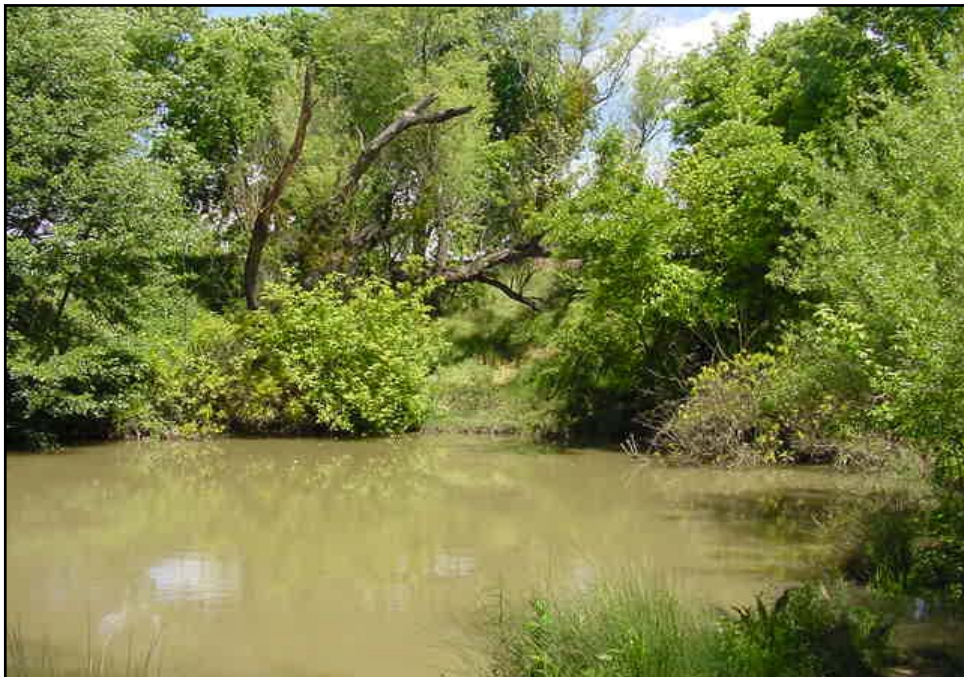
View of the discharge side into Elk Slough.
The structure is under water.

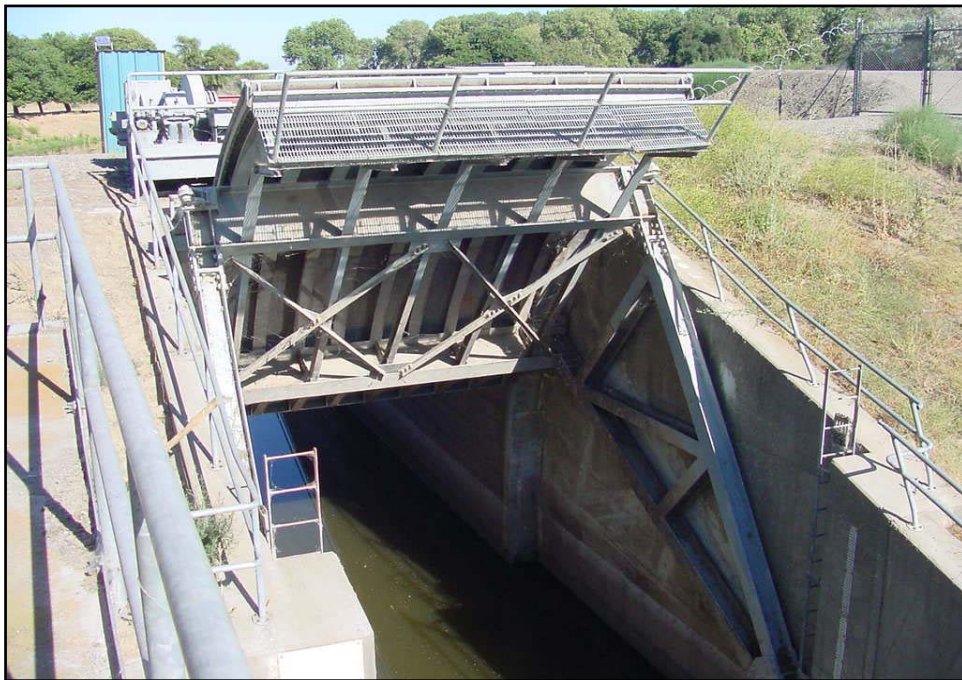
View of the radial gate. During high water the gate is closed to prevent flooding of Wetherbee Lake island.

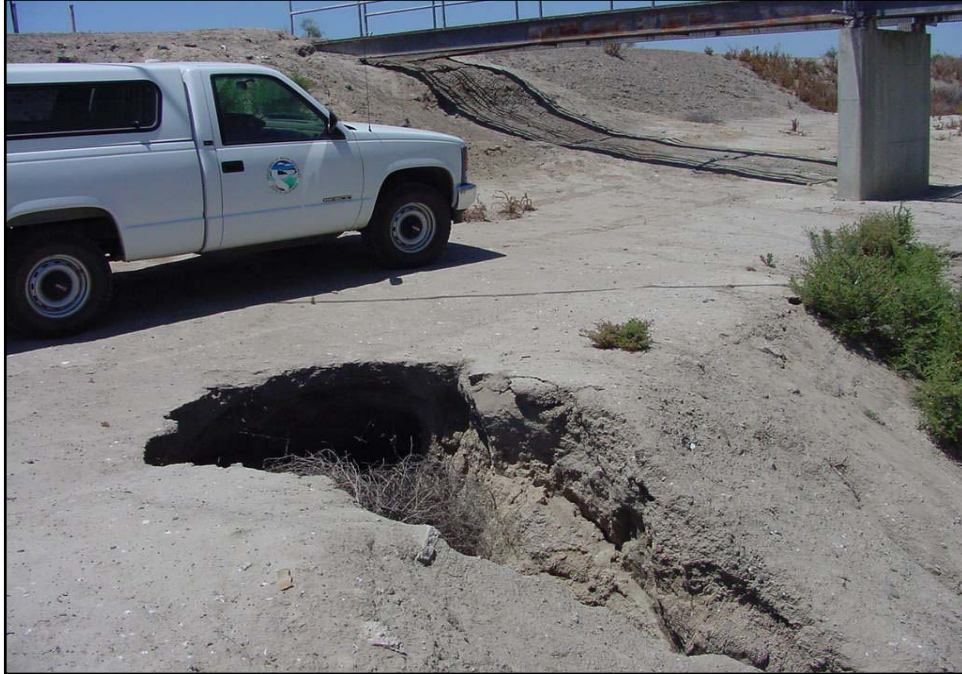
1. Condition of main pump structure.
 - a. There are several large holes around the bank between the structure and the levee. The holes appear to have been caused by rain runoff and are very deep.
2. Condition of pumps and motors.
 - a. Good.
3. Condition of the switchboard house and the electrical equipment.
 - a. Good.
4. Condition of the control gates, mechanism and flap gates.
 - a. Good.
5. Condition of the trash racks.
 - a. Good.
6. Condition of the gauging house and equipment.
 - a. Good.
7. Condition of the revetment.
 - a. Good.
8. Accumulation of trash and debris around structure or in the channel.
 - a. Minimal.
9. Vegetation around the structure or in the channel.
 - a. None.
10. Comments:
 - a. It is unclear if the holes in the bank will have an adverse effect on the pumping facility. Monitor and repair as needed.

**Looking at one of several large holes in the
bank between the structure and the levee.**

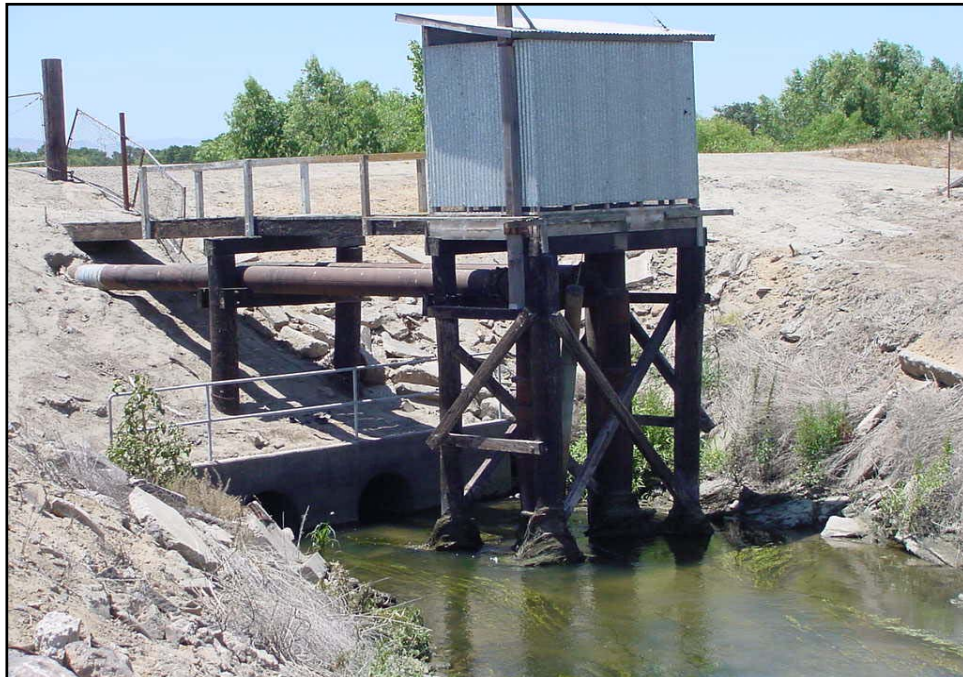
1. Condition of main pump structure.
 - a. Fair.
2. Condition of abutments and wing walls.
 - a. Good.
3. Condition of pumps and motors.
 - a. It is not clear if the pumps are operational. They do not appear to have been tested or run in some time.

4. Condition of control gate, mechanisms and flap gates.
 - a. Good.
5. Condition of the trash racks.
 - a. The trash racks were not present at the time of the inspection.

Looking at the pumping plant intake.

8. Comments:
 - a. The reclamation district is responsible for testing the pumps prior to flood season.
 - b. Replace the trash racks.
 - c. Monitor growth and remove as necessary.

- d. Poor maintenance.
 - e. The district should consider replacement or reconstruction of the pump house, platform and trash racks.

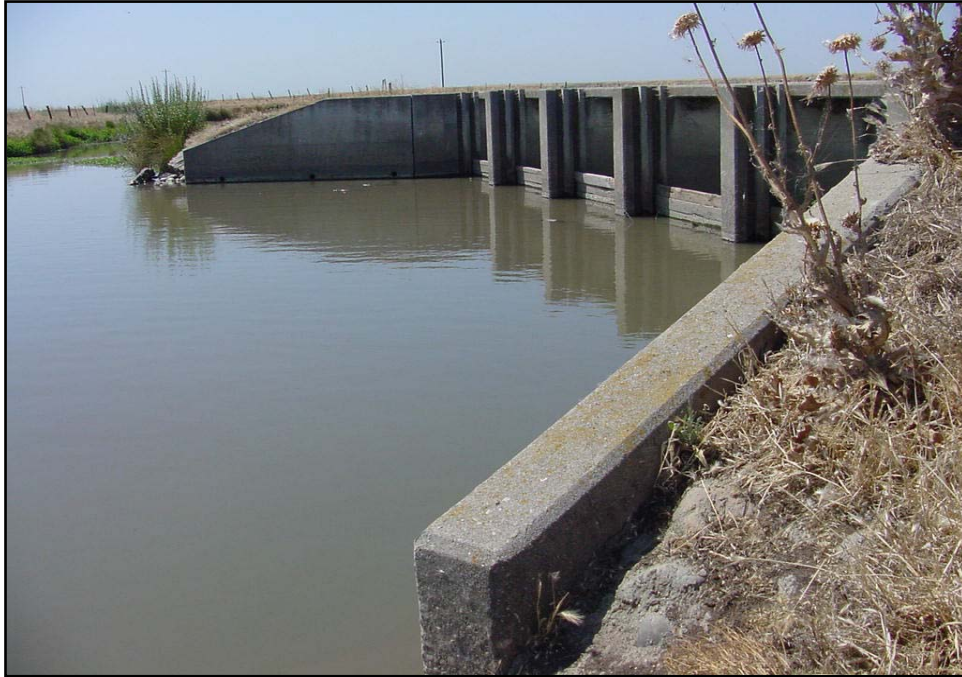
BEAR CREEK DIVERSION STRUCTURE

- 1. Condition of concrete weir structure and stilling basin.**
 - a. Good.**
- 2. Condition of concrete abutments and wing walls.**
 - a. Good.**
- 3. Condition of revetment.**
 - a. Damage to both banks upstream of the structure.**
- 4. Accumulation of trash and debris around the structure or in the channel.**
 - a. None.**
- 5. Vegetation around the structure or in the channel.**
 - a. Minimal.**
- 6. Comments:**
 - a. Monitor and repair revetment as needed.**
 - b. Remove vegetation.**
 - c. Good maintenance.**

Looking at the upstream side of the structure.

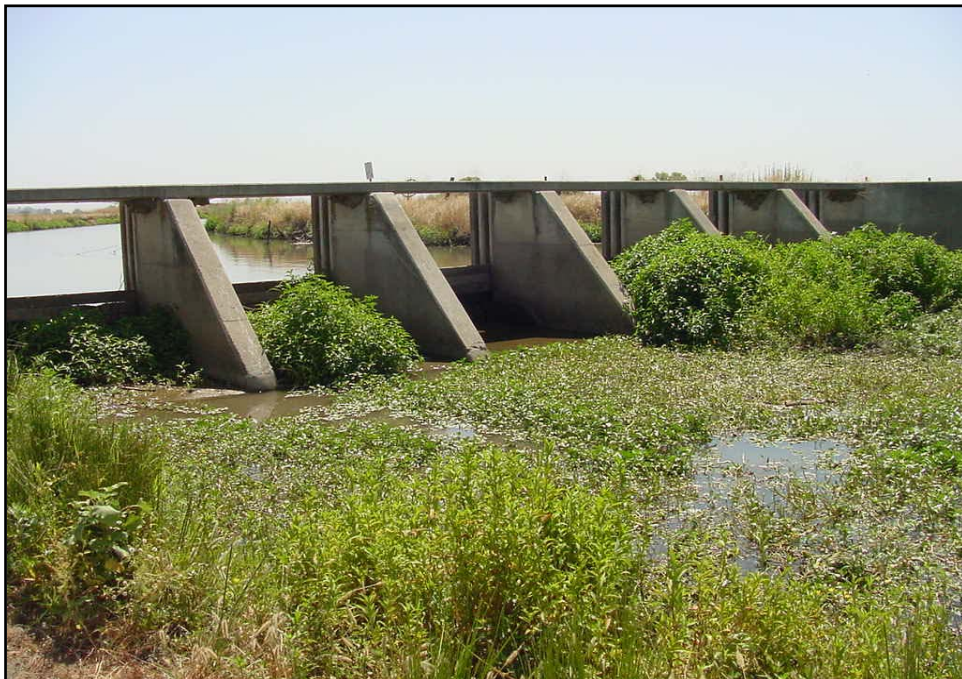
Looking at the downstream side of the structure.

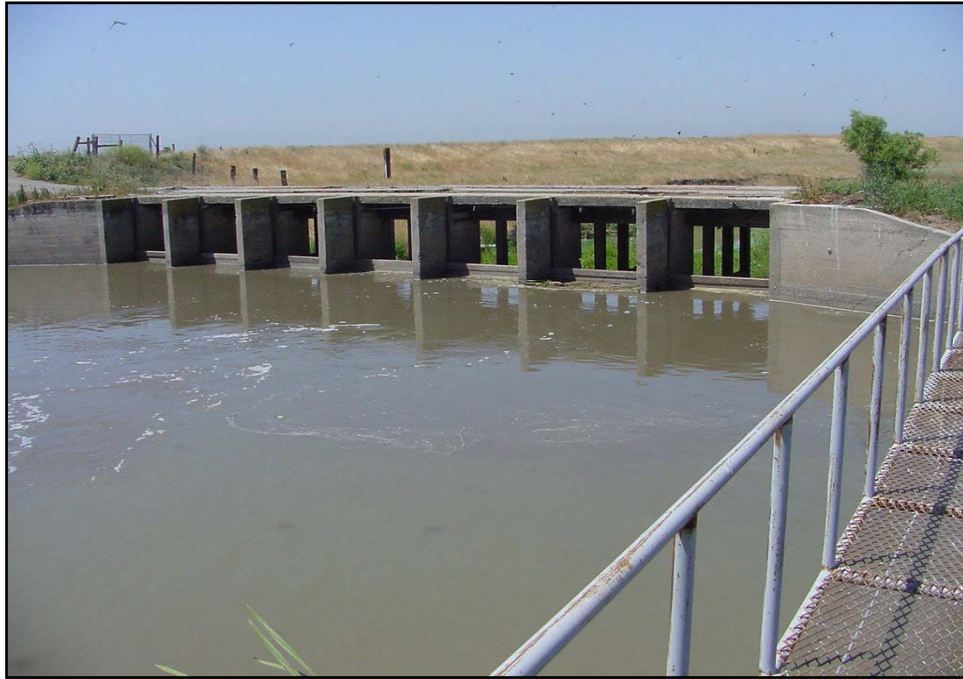
OWENS CREEK CONTROL STRUCTURE

- 1. Condition of concrete control structure.**
 - a. Good**
- 2. Condition of abutments and wing walls.**
 - a. There are one-half inch cracks, four to five feet in length in the right and left bank abutments.**
- 3. Condition of stop logs and supports.**
 - a. Good.**
- 4. Accumulation of trash and debris around the structure or in the channel.**
 - a. None.**
- 5. Vegetation around the structure or in the channel.**
 - a. Minimal.**
- 6. Comments:**
 - a. This structure was in existence prior to the construction of the project and is a part of the Lower San Joaquin Levee District but is operated by Eastside Canal Company.**
 - b. Monitor and repair the cracks in the abutments as needed.**
 - c. Fair maintenance.**

Looking at the upstream side of the structure from the left bank.

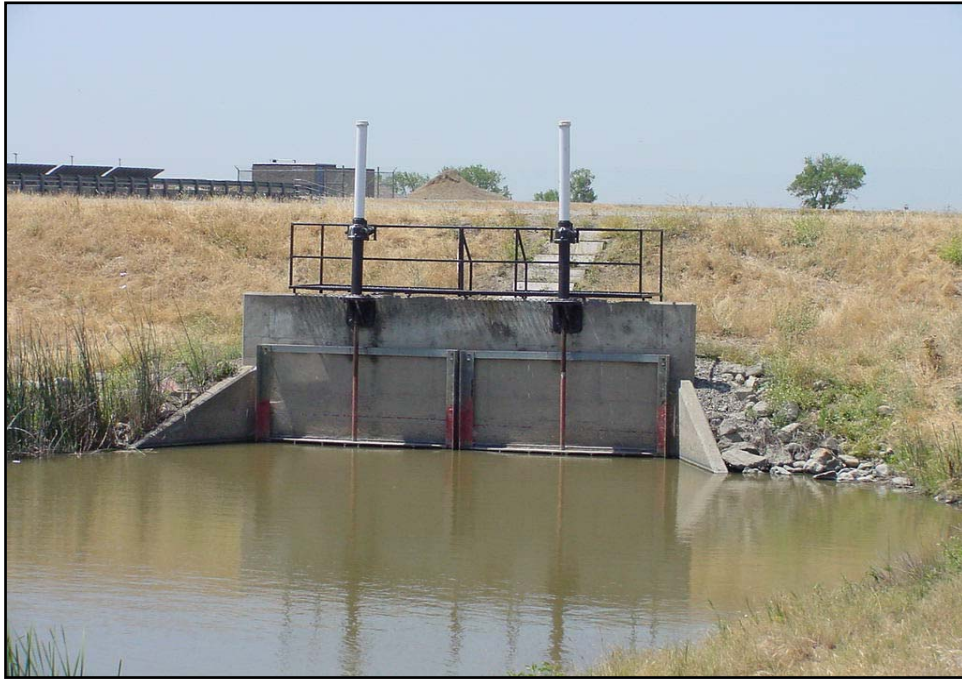
OWENS CREEK OVERFLOW STRUCTURE

View of the two 72 inch slide gates at the intake side of the structure.

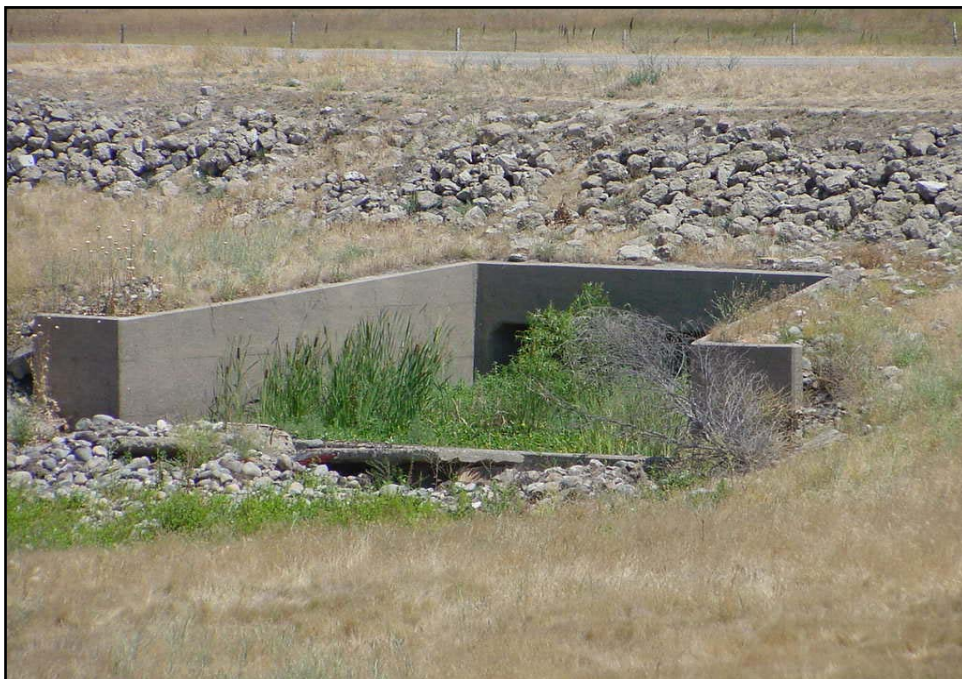
- 1. Condition of the concrete overflow structure.**
 - a. Fair, the concrete apron on the discharge side is damaged.**
- 2. Condition of the abutments and wing walls.**
 - a. Good.**
- 3. Condition of the control gates and mechanism.**
 - a. Good.**
- 4. Condition of the revetment.**
 - a. Good.**
- 5. Accumulation of trash and debris around the structure or in the channel.**
 - a. None.**
- 6. Vegetation around the structure or in the channel.**
 - a. Minimal.**
- 7. Comments:**
 - a. Fair maintenance.**
 - b. Repair the concrete apron on the discharge side of the structure.**

View of the discharge side of the structure into the Eastside Bypass.

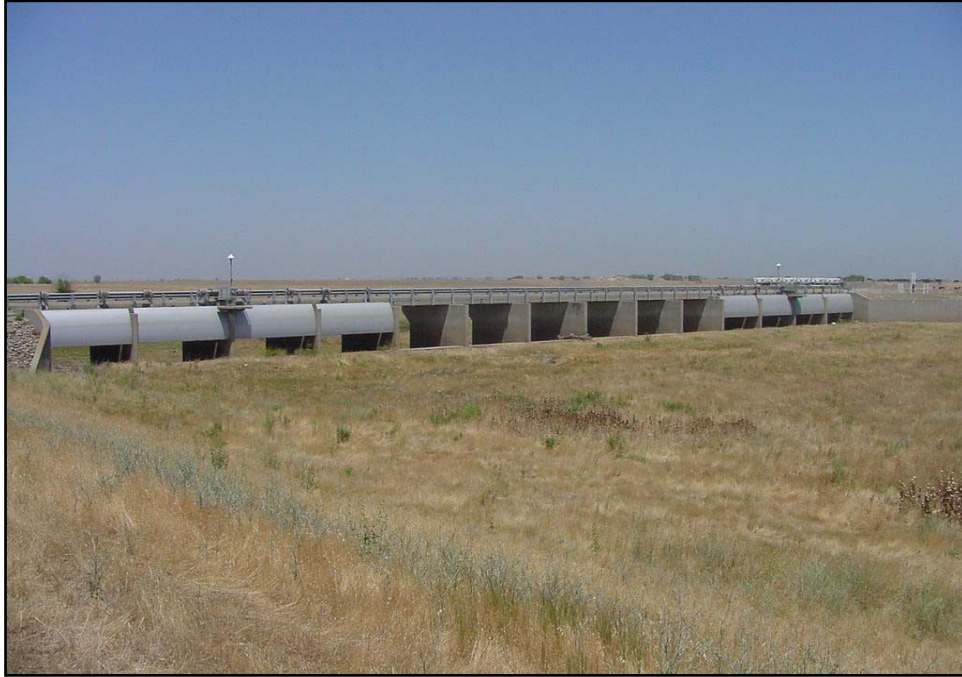
MARIPOSA BYPASS CONTROL STRUCTURE

- 1. Condition of concrete control structure.**
 - a. Good.**
- 2. Condition of abutments and wing walls.**
 - a. Good.**
- 3. Condition of radial gate and mechanisms.**
 - a. Good.**
- 4. Condition of electrical equipment.**
 - a. Good.**
- 5. Condition of gate hoist equipment.**
 - a. Good.**
- 6. Condition of revetments.**
 - a. Good.**
- 7. Accumulations of trash and debris around the structure or in the channel.**
 - a. None.**
- 8. Vegetation around the structure or in the channel.**
 - a. None.**
- 9. Comments:**
 - a. All the equipment is tested and serviced prior to flood season each year. This structure is well maintained and is in excellent condition.**
 - b. Good maintenance.**

Looking at the upstream side of the structure.

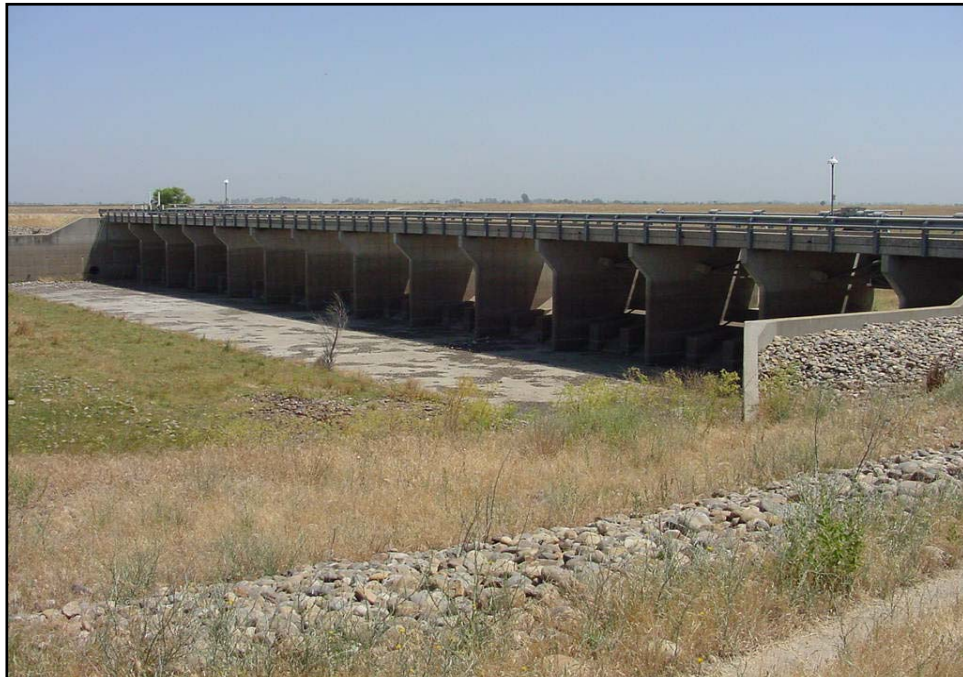
Looking at the downstream side of the structure.

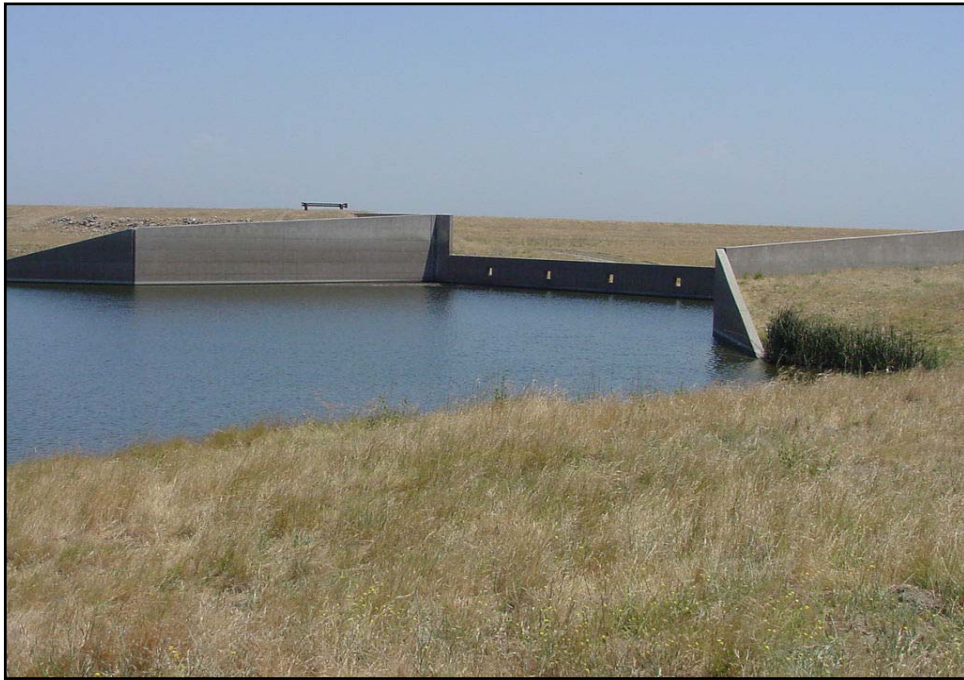
MARIPOSA BYPASS DROP STRUCTURE

Looking at the downstream side of the structure.

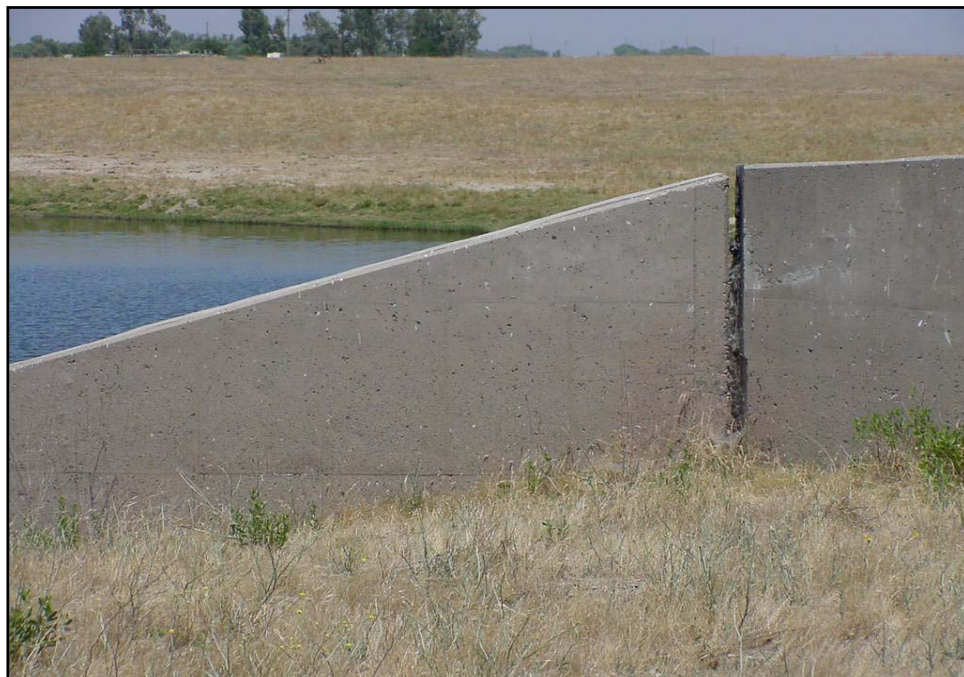
- 1. Condition of concrete drop structure, stilling basin, and velocity dissipaters.**
 - a. Good.**
- 2. Condition of concrete abutments and wing walls.**
 - a. Left wing wall has three-fourth inch separation at the joint but otherwise it is in excellent condition.**
- 3. Condition of revetment.**
 - a. Good.**
- 4. Accumulation of trash and debris around the structure or in the channel.**
 - a. None.**
- 5. Vegetation around the structure or in the channel.**
 - a. None.**
- 6. Comments:**
 - a. Good maintenance.**

View of the left bank wing wall and the three inch joint separation.

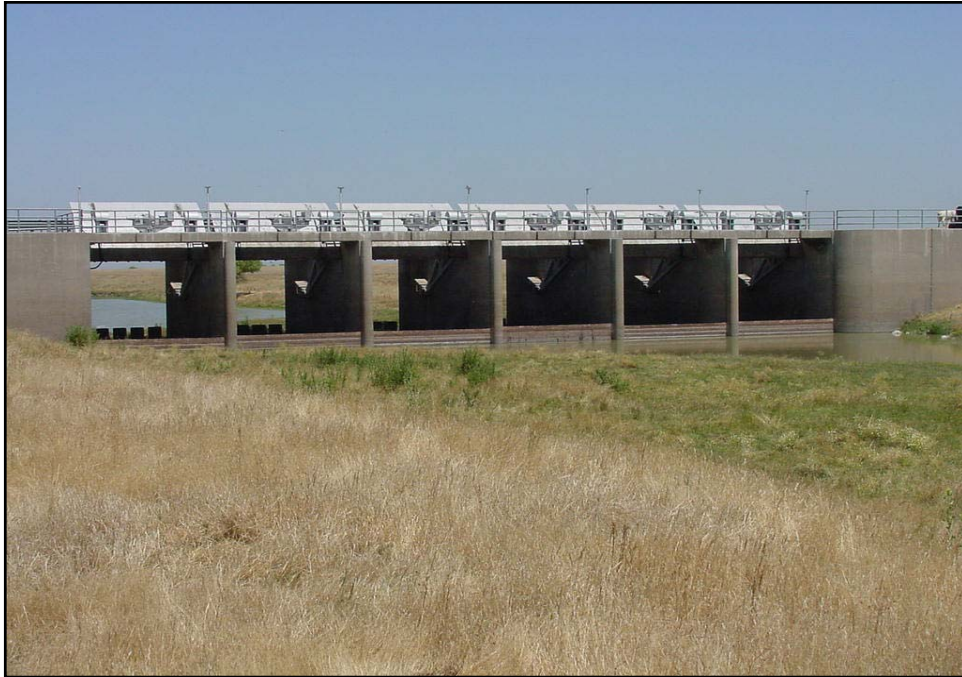
EASTSIDE BYPASS CONTROL STRUCTURE

a. All the equipment is tested and serviced prior to flood season each year. This structure is well maintained and is in excellent condition.

Looking at the upstream side of the structure.

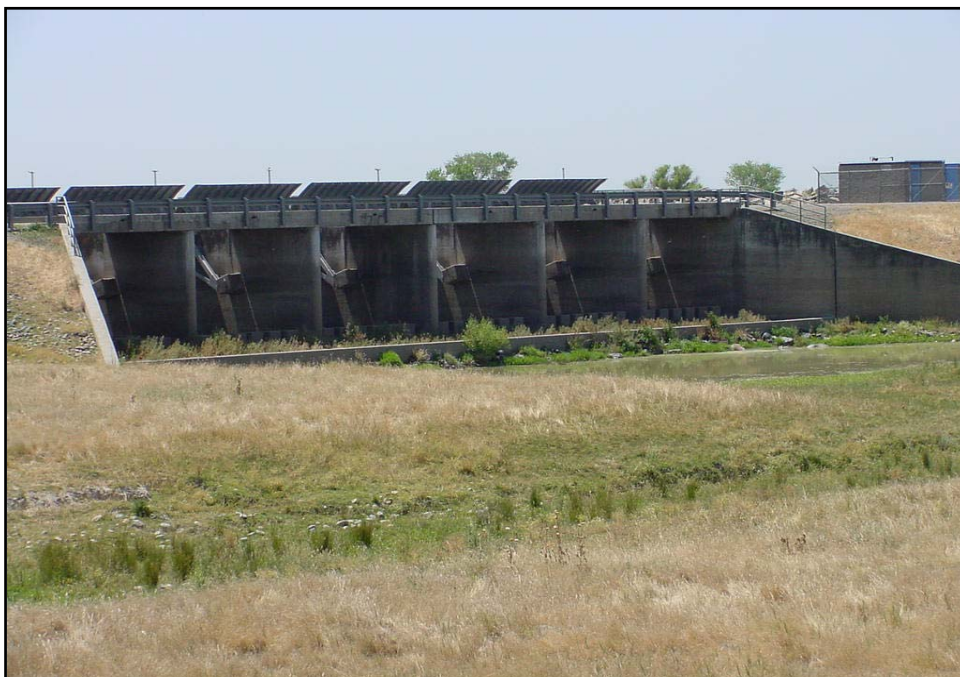
Looking at the downstream side of the structure.

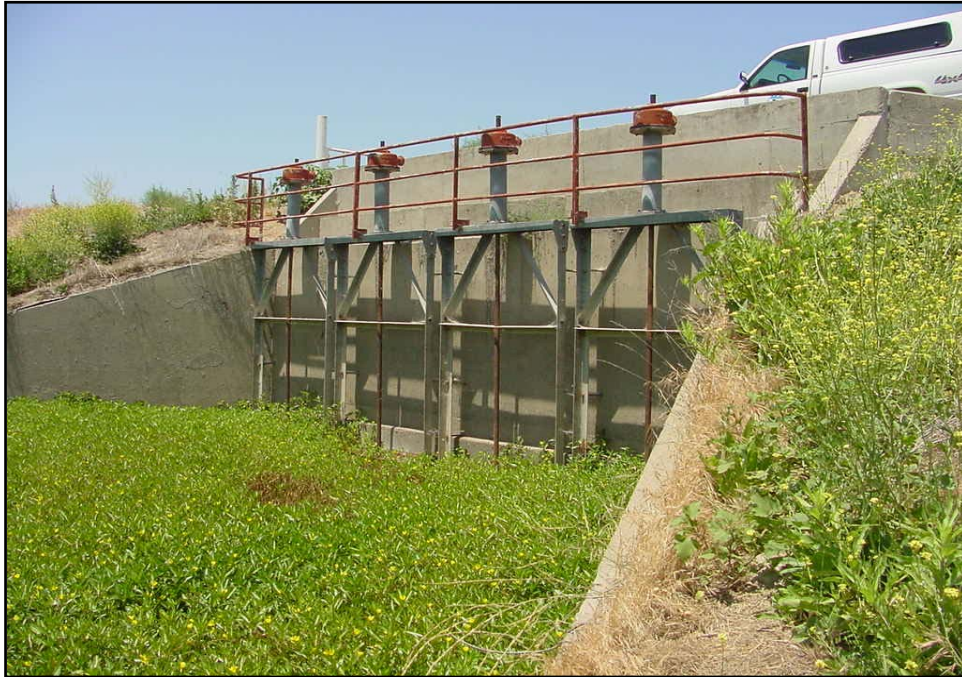
SAN JOAQUIN RIVER STRUCTURE AND SAND SLOUGH STRUCTURE

- 1. Condition of San Joaquin River Structure.**
 - a. Good.**
- 2. Condition of the abutments, wing walls, and bulkheads.**
 - a. Good.**
- 3. Condition of control gates and mechanisms.**
 - a. Good.**
- 4. Condition of the Sand Slough Structure (Parshall flume) and wing walls.**
 - a. Good.**
- 5. Condition of the revetment.**
 - a. Good.**
- 6. Accumulation of trash or debris around structure or in the channel.**
 - a. None.**
- 7. Comments:**
 - a. This structure is tested and serviced prior to each flood season.**
 - b. Good maintenance.**

View of the control gates at the intake of the structure.

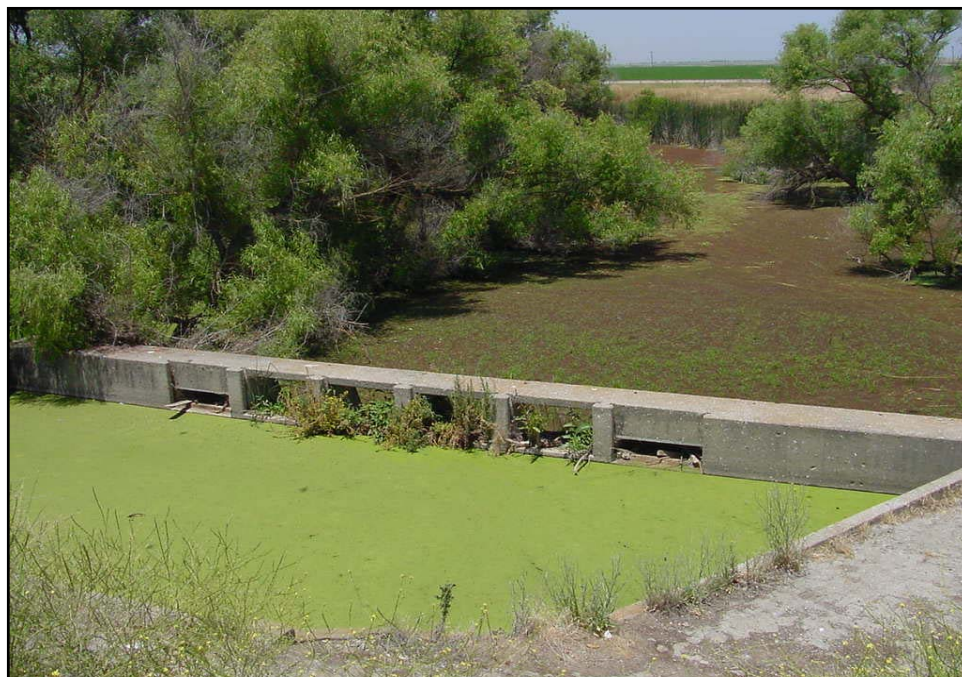
Looking at the outlet channel.

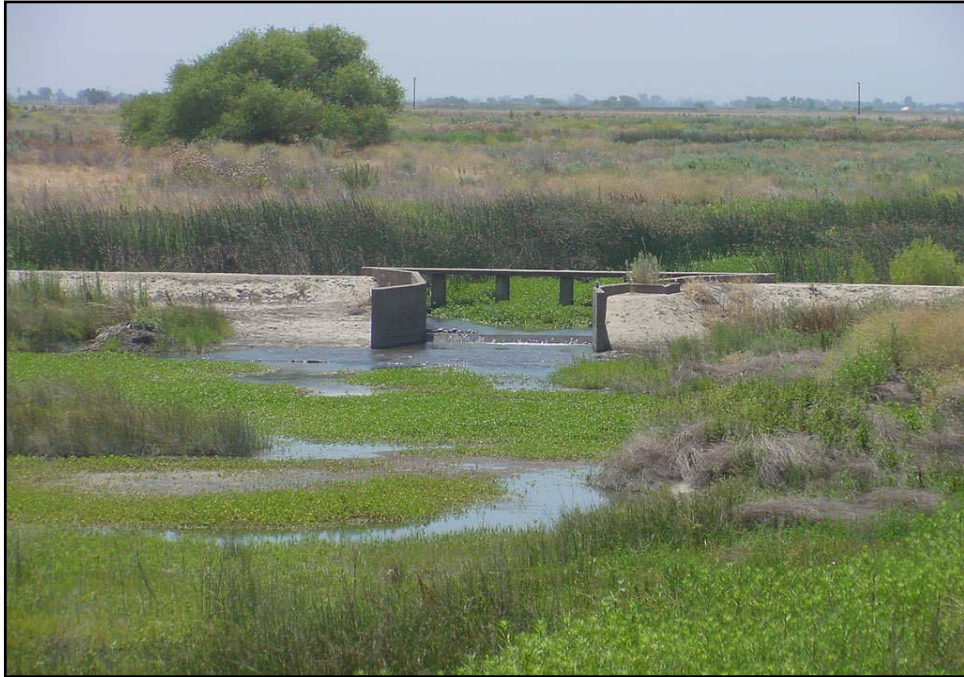
SAN JOAQUIN RIVER STRUCTURE AND SAND SLOUGH STRUCTURE

**Looking upstream at the Sand Slough Structure
from the Washington Street Bridge.**

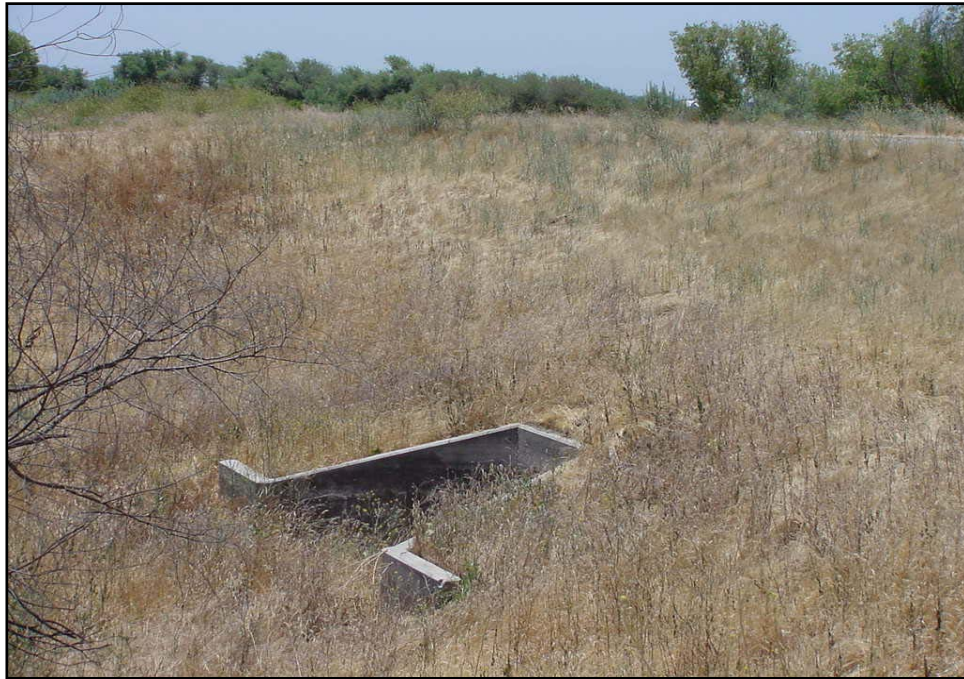
FRESNO RIVER DRAINAGE STRUCTURE

Looking at the intake side of the structure.

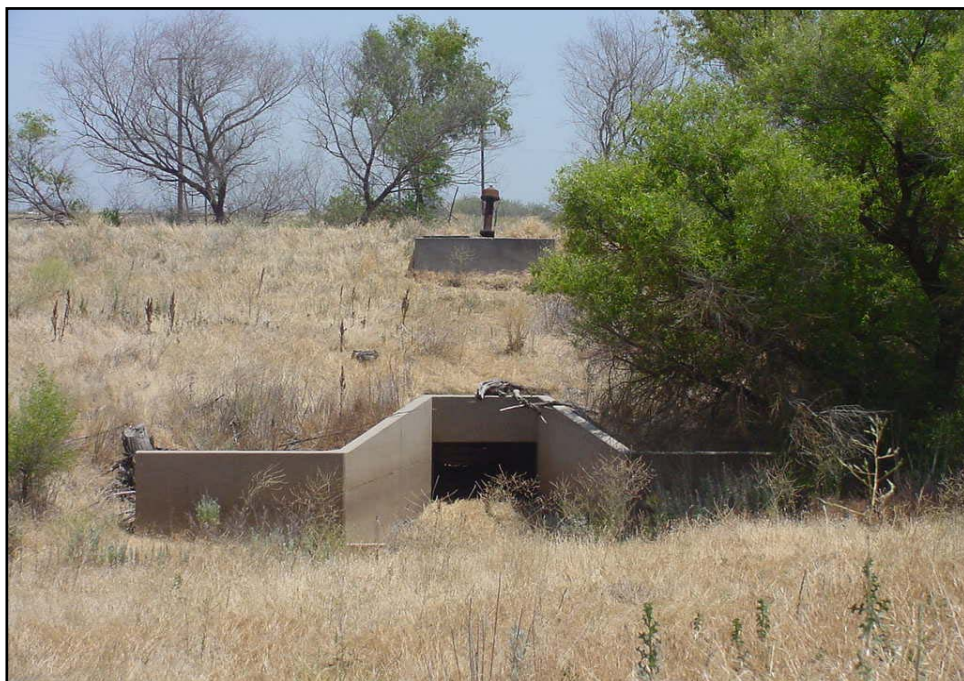
- 1. Condition of concrete drainage structure.**
 - a. Good.**
- 2. Condition of abutments and wing walls.**
 - a. Good.**
- 3. Condition of control gate, mechanism, and flap gate.**
 - a. The control mechanism is bent.**
- 4. Condition of revetment.**
 - a. Good.**
- 5. Accumulation of trash and debris around the structure or in the channel.**
 - a. Good.**
- 6. Vegetation around the structure or in the channel.**
 - a. None.**
- 7. Comments:**
 - a. The control mechanism for the gate needs to be straightened but otherwise, this structure is in good condition.**

**Looking at the discharge side of the
structure and the control mechanism.**

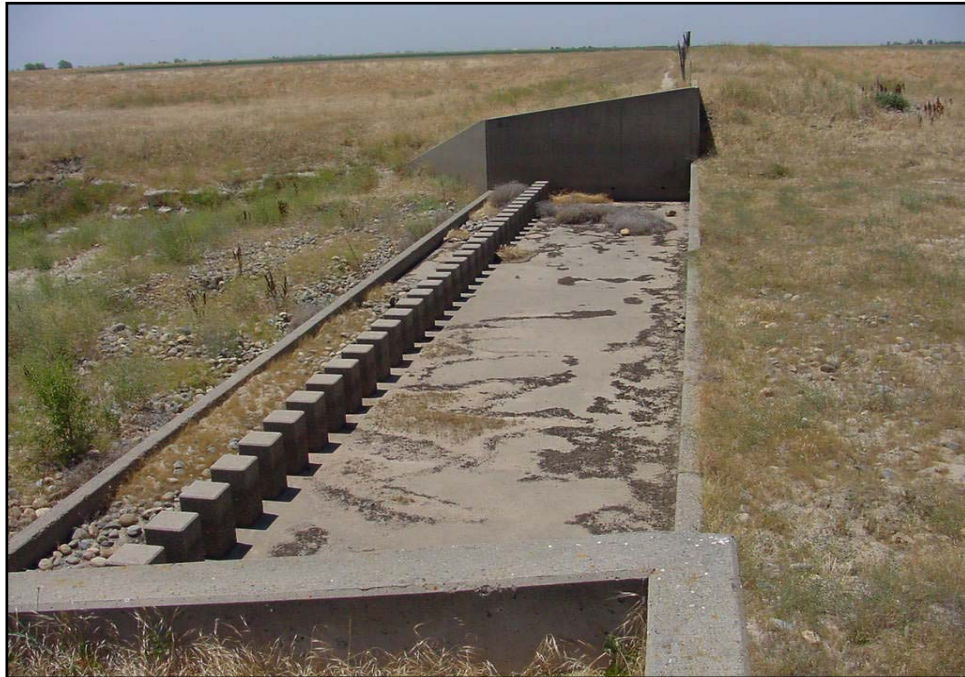
ASH SLOUGH DROP STRUCTURE NO. 1

- 1. Condition of concrete drop structure, stilling basin, and velocity dissipaters.**
 - a. Good.**
- 2. Condition of concrete abutments and wing walls.**
 - a. Good.**
- 3. Condition of revetment.**
 - a. Good.**
- 4. Accumulation of trash and debris around the structure or in the channel.**
 - a. None.**
- 5. Vegetation around the structure or in the channel.**
 - a. None.**
- 6. Comments:**
 - a. Good maintenance.**

Looking at the abutments, stilling well and velocity dissipaters.
